Inspection Report

SAMPLE

Site Overview

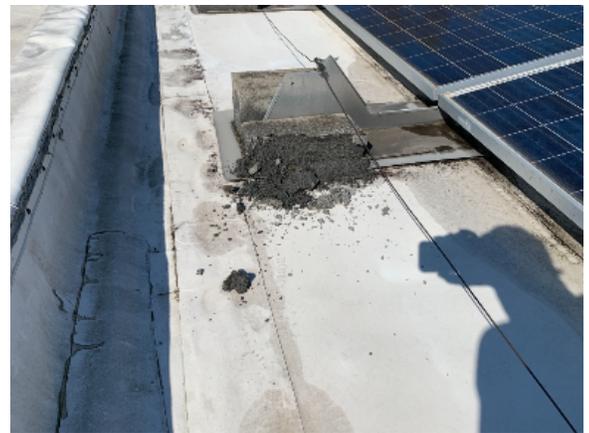
Solar array ballast blocks disintegrating

Solar covers 90% of this roof section. The array is ballasted with cinder blocks, the existing cinder blocks are degrading/ disintegrating. These blocks overtime left to decompose will no longer function as ballast thus allowing the array to potentially blow off the roof system.

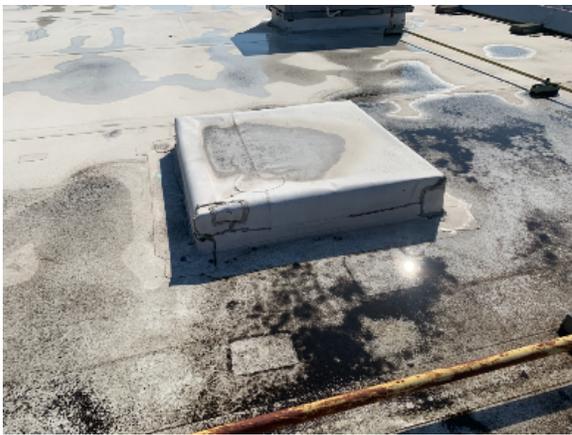
Curb - Abandoned

Quantity: 2 EA

Units are removed from abandoned curb leaving the curb open for roof leaks.

Remove existing curb, install steel decking, install matching insulation, install waterproofing membrane to match existing roof system.

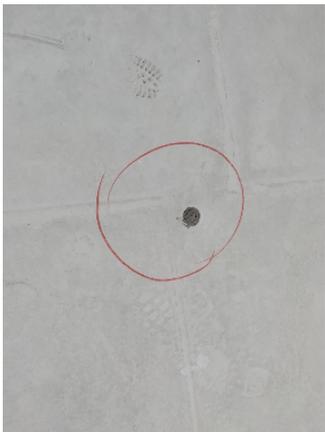
Membrane - Temporary Repair

Quantity: 30 EA

Leak location detected in the roof system allowing water to enter into the building.

The existing roof system is a TPO thermoplastic membrane mechanically attached with plates and screws to the steel substrate. There are approx. thirty (30) areas of temporary repairs completed with caulking through out the roof system. This might have been done as the existing TPO is no longer weldable.

Clean the area to the best of our ability and apply water proof sealant to temporarily solve the roof leak.

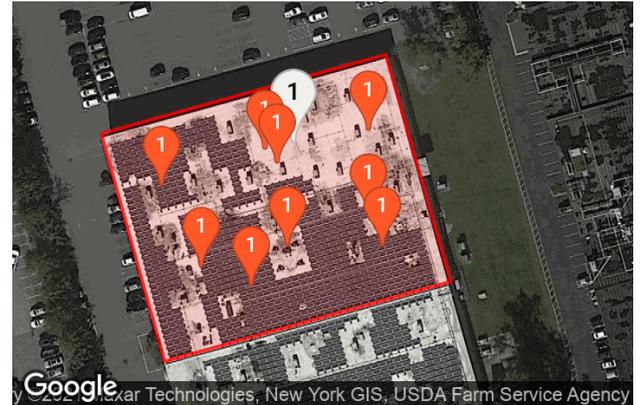
Drainage-Clogged drain screen

Quantity: 11 ea

Debris collected in drain screen.

The roof system is very dirty and has algae in large ponding areas as the solar array is hindering the positive drainage of the roof system. The drain screens are in need of cleaning and must be maintained every three (3) months to ensure positive drainage of the roof system.

Remove existing drain screen thoroughly clean and re-install

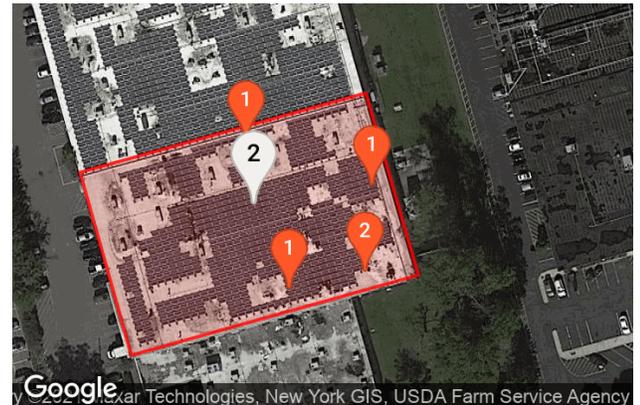
Curb - Abandoned

Quantity: 3 EA

Units are removed from abandoned curb leaving the curb open for roof leaks.

Remove and discard curb from roof system. Install steel decking, install matching insulation, install TPO membrane.

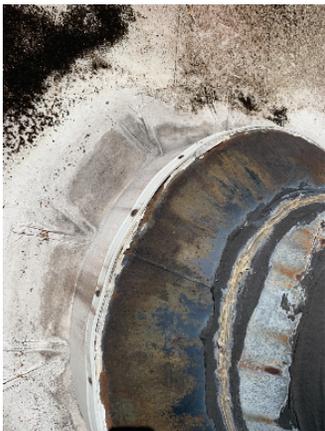
Curbs - Termination bar seal (Emergency)

Quantity: 12 LF

The seal over the termination bar around the perimeter of the curb appears to be degraded and is prone to allow water to enter into the roof system.

Either trowel out caulking and re-apply or remove termination bar and re-install around the perimeter of the curb.

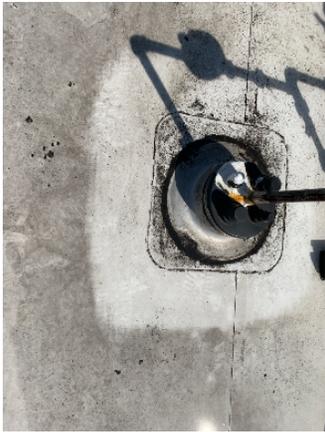
Penetrations - Pitch pan failing (Emergency)

Quantity: 1 EA

Pitch pan failing due to no flashings installed to the portals curb, portals caulked to roof system.

The pitch pocket (with no flashing) should be addressed, as well as the large heat stack where the existing sealant is failed and letting water into the roof system.

Install new TPO flashings per the manufacturers guidelines.

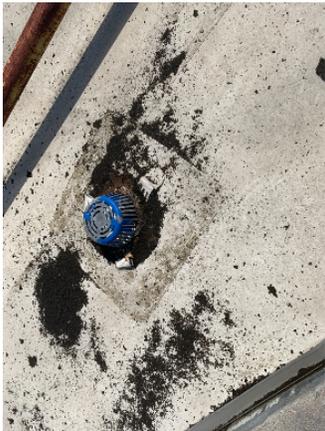
Drainage-Clogged drain screen

Quantity: 11 ea

Debris collected in drain screen.

The roof system is very dirty and has algae in large ponding areas, as the solar array is hindering the positive drainage of the roof system. The drain screens are in need of cleaning and must be maintained every three (3) months to ensure positive drainage of the roof system.

Remove existing drain screen thoroughly clean and re-install

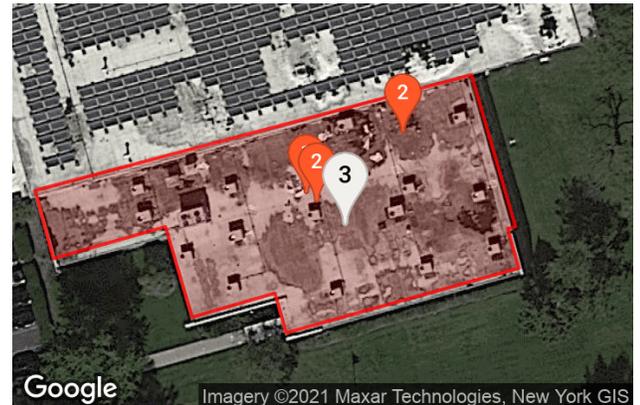
Debris - Material left on roof

Quantity: 10 EA

Loose debris has a high probability of blowing around on the roof and causing damage to the waterproofing membrane.

All the roof systems walk pad from the walk way and at the mechanical units are piled up in the middle of the roof system. These items should be removed from the roof system, as they have a great possibility of blowing across the roof system and causing damage. Some of the walk pads have already blown off the roof system and are laying on the east side lawn.

Remove loose debris from roof area and include as part of routine preventative maintenance. Inspect and repair damaged membrane resulting from wind blown debris. Price is per bag.

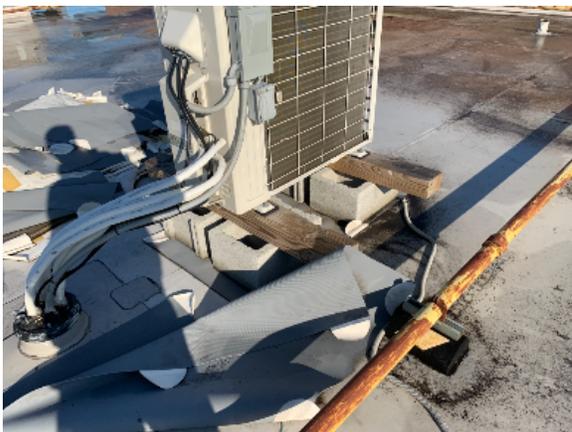
A/C - Wood Runner Damaged Membrane

Quantity: 12 EA

The existing wood runner is damaging the existing roof membrane.

Repair the roof surface where the damage occurs. Install a new wood runner and roof pad.

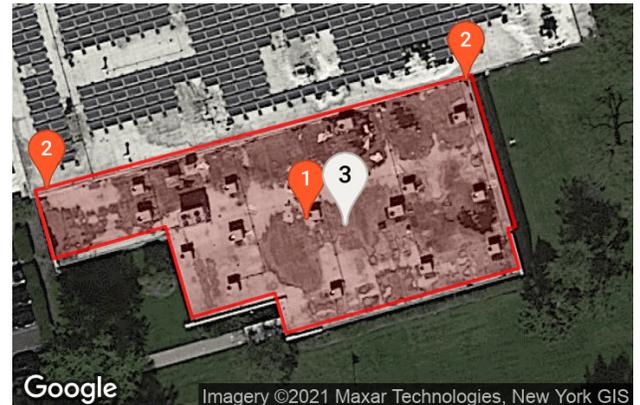
Penetrations - Abandoned penetration

Pitch pan and penetrations have been abandoned. The abandoned penetrations allow water to infiltrate the roof flashing, roof system and building interior.

There is one (1) abandoned vent pipe that should be removed and cap off with PVC membrane.

Remove abandoned pitch pan or penetration and repair roof membrane using compatible materials.

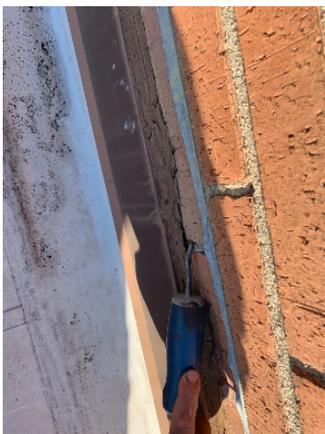
Perimeter - Counter Flashing Caulk Failure (Emergency)

Quantity: 192 LF

Sealant along counter flashing is failed or failing and allowing water to migrate into the roof system.

Remove the old caulking, wire brush as needed, prime the area and install new sealant tooled to ensure water tightness.

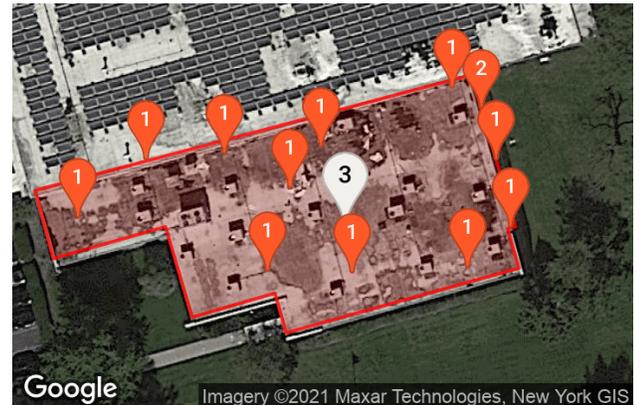
Debris - Trash on Roof

Quantity: 10 EA

Loose debris has a high probability of blowing around on the roof and causing damage to the waterproofing membrane.

Remove loose debris from roof area and include as part of routine preventative maintenance. Inspect and repair damaged membrane resulting from wind blown debris.

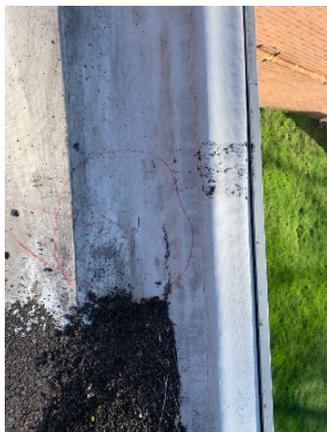
Membrane- Sheet is failing (Emergency)

Quantity: 1 ea

The membrane due to age and UV is deteriorating.

There are signs of the existing PVC membrane beginning to fail as the top of the membrane is creasing. This condition should be monitored moving forward so you don't experience un wanted leaks.

Clean, prepare the area (s) as to accept a new layer of membrane.

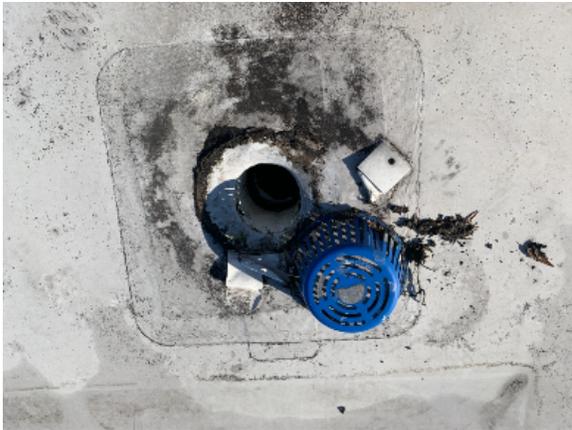
Drainage - Missing drain bolts

Quantity: 4 EA

The existing drain screen is not secured to the roof system. As the drain assembly is a membrane retrofit drain.

The existing roof system is a PVC thermoplastic membrane mechanically attached with plates and screws to the steel substrate. This roof section ponds a lot of water due to poor drainage system in place. This roof section only has four (4) drains on it. The roof system is covered with debris from trees. The existing drain screens are clogged as well as not attached to the drain assemblies as there is no clamping rings present. The drain assemblies are the manufacturers membrane retrofit drains sold with the system warranty.

Install PVC straps to roof system and screen, as to keep screen in place.

The drain screens should be strapped to the roof system utilizing the manufacturers PVC membrane and bolts. The drain screens are in need of cleaning and must be maintained every three (3) months to ensure positive drainage of the roof system.
