Inspection Report

SAMPLE

Site Overview

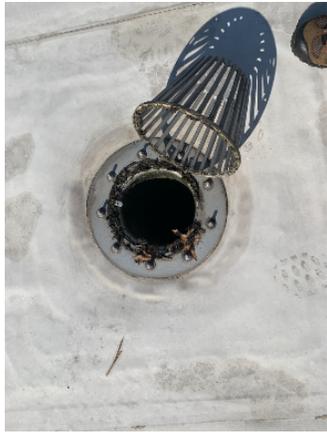
Drainage 11-8", 2 Of the 8 are retrofit drains, 9-8" are cast iron internal drains.

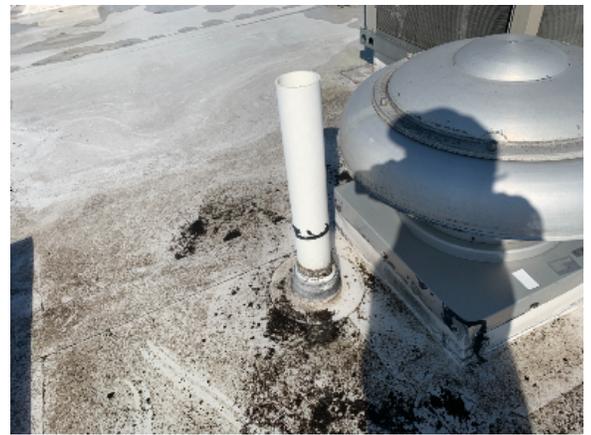
Plumbing vents 4-4"

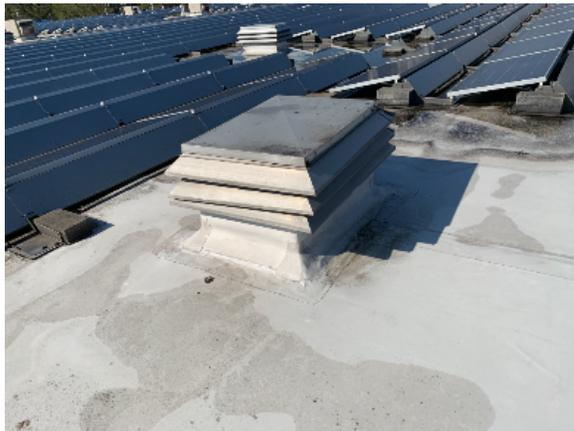
Gravity vent 2-2 x 3, 2-3 x 8

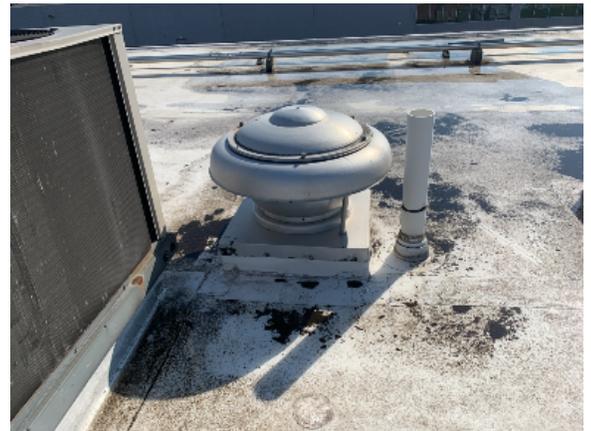
EF 2-3 x 3

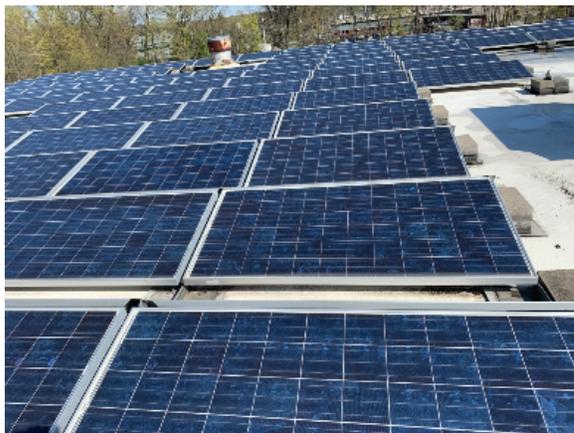
Solar Array covers 90% of roof system

Solar covers 90% of this roof section. The array is ballasted with cinder blocks, the existing cinder blocks are degrading/ disintegrating. These blocks overtime left to decompose will no longer function as ballast thus allowing the array to potentially blow off the roof system.

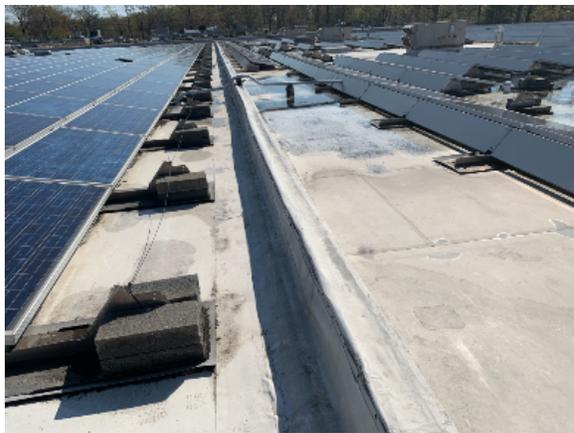
EJ divides sections 1&2 253'

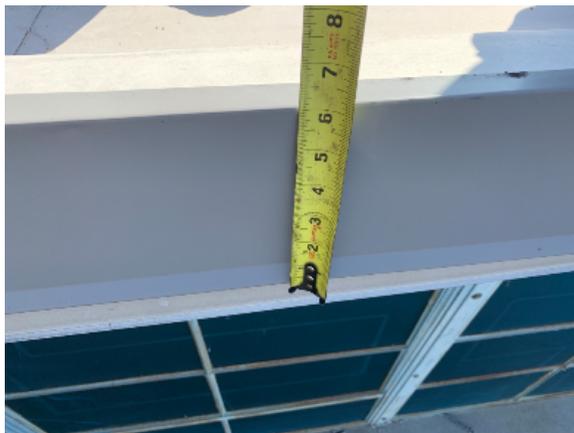
Edge metal 6" face

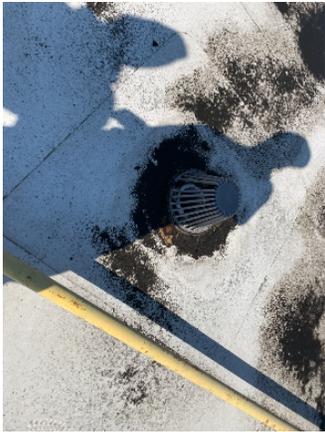
Drainage-Clogged drain screen

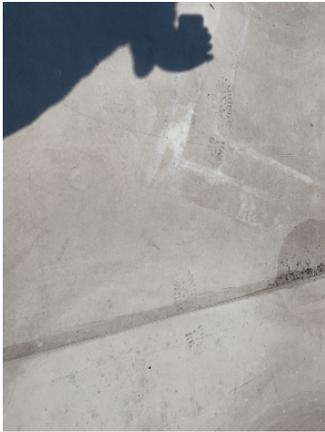
1

No test cut performed during inspection It is believed the existing roof system is PVC membrane over 2" EPS insulation over steel deck substrate.

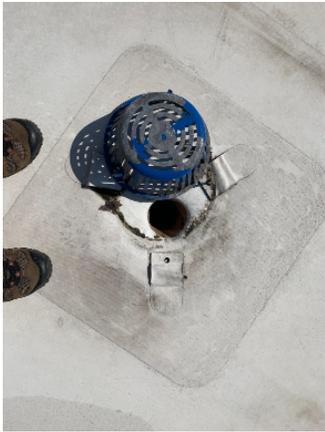
Drainage 10- 4"

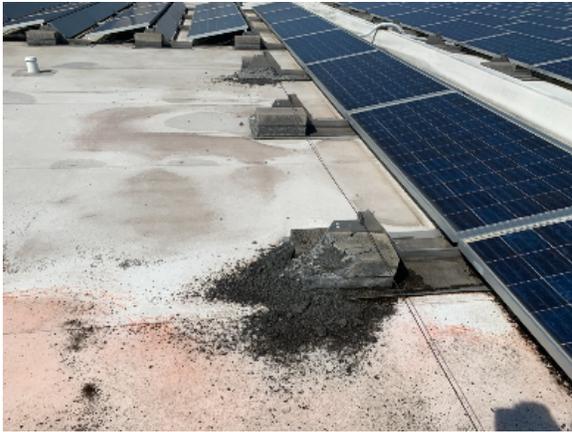
Solar array ballast blocks disintegrating

The existing roof system is a PVC thermoplastic membrane mechanically attached with plates and screws to the steel substrate. Solar covers 90% of this roof section. The array is ballasted with cinder blocks, the existing cinder blocks are degrading/ disintegrating. These blocks overtime left to decompose will no longer function as ballast thus allowing the array to potentially blow off the roof system.

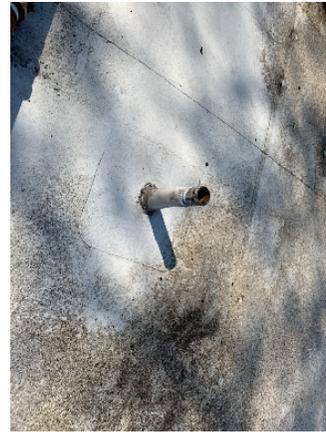
Plumbing vents 3-3"

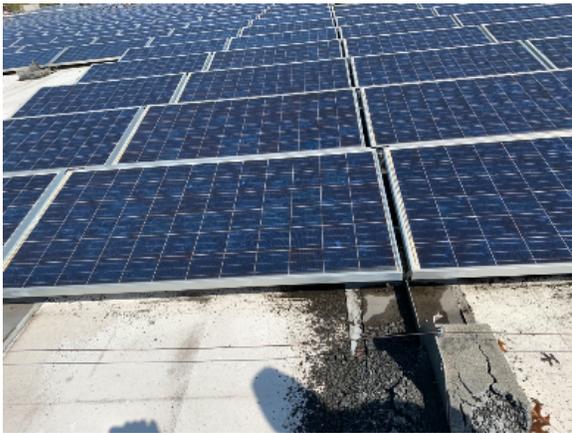
Solar array covers 90% of the roof system

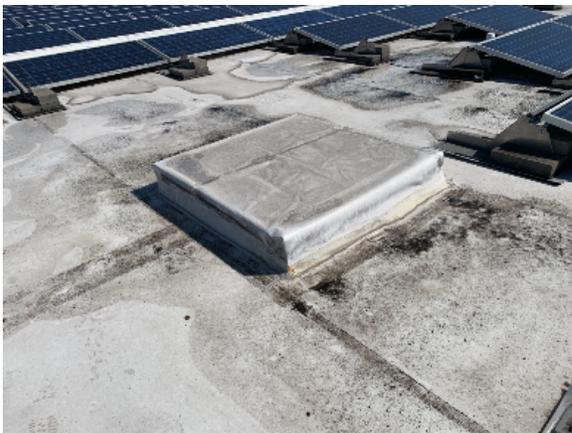
Curb - Abandoned

Units are removed from abandoned curb leaving the curb open for roof leaks.

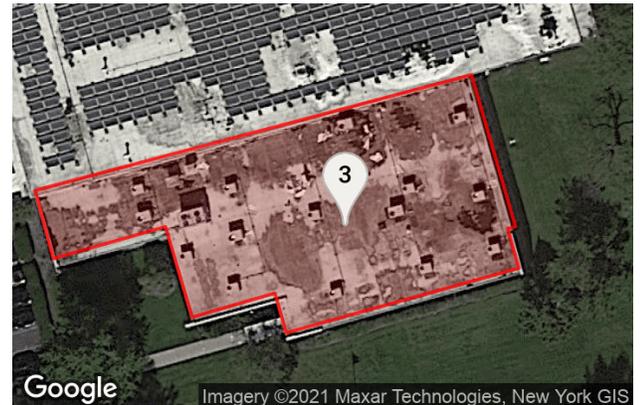
No test cut performed during inspection. It is believed the existing roof system is PVC membrane over 2" Polyisocyanurate insulation over steel deck substrate.

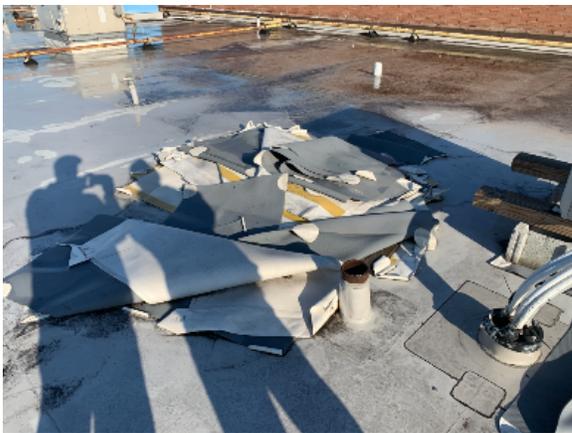
Debris - Material left on roof

Loose debris has a high probability of blowing around on the roof and causing damage to the waterproofing membrane.

Remove loose debris from roof area and include as part of routine preventative maintenance. Inspect and repair damaged membrane resulting from wind blown debris. Price is per bag.

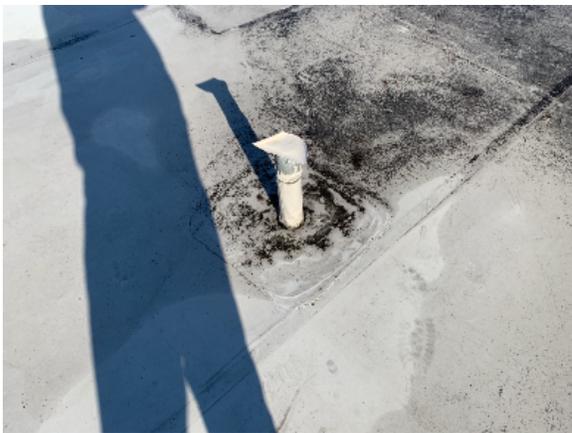
Penetrations - Abandoned penetration

Pitch pan and penetrations have been abandoned. The abandoned penetrations allow water to infiltrate the roof flashing, roof system and building interior.

Remove abandoned pitch pan or penetration and repair roof membrane using compatible materials.

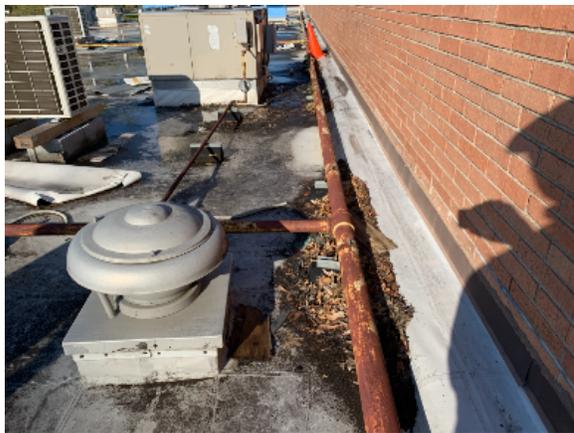
Debris - Trash on Roof

Loose debris has a high probability of blowing around on the roof and causing damage to the waterproofing membrane.

All the roof systems walk pad from the walk way and at the mechanical units are piled up in the middle of the roof system. These items should be removed from the roof system, as they have a great possibility of blowing across the roof system and causing damage. Some of the walk pads have already blown off the roof system and are laying on the east side lawn.

Remove loose debris from roof area and include as part of routine preventative maintenance. Inspect and repair damaged membrane resulting from wind blown debris.
